Aansluitingen API 4

Beijer Automotive BV Schijndel Holland

Connections API 4

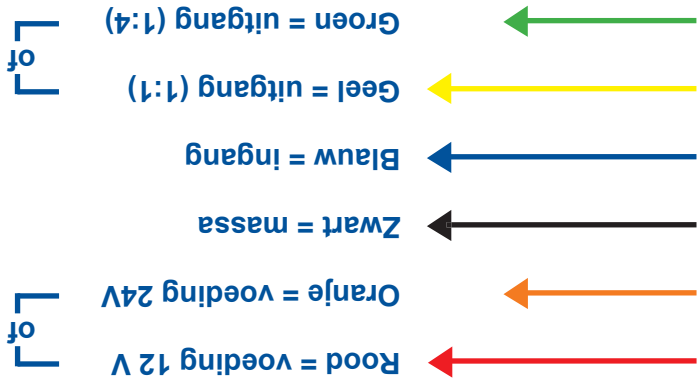
De **rode** draad op een 1A gezeekerde voeding aansluiten (12 volt), of sluit de **oranje** (korte) draad aan op een 1A gezeekerde voeding (24 volt).

De **zwarte** draad op een goede massa aansluiten.

De **blauwe** draad aansluiten op het signaal van het voertuig.

De **gele** draad aansluiten op de ingang van het systeem dat u aansluit voor een niet gedeelde frequentie ingang, of sluit de **groene** (korte) draad aan op de ingang van het systeem dat u aansluit voor een frequentie ingang gedeeld door 4.

Controleer na inbouw van elektronische apparatuur in voertuigen altijd de werking van belangrijke functies in het voertuig en kijk goed of er geen storings- of diagnose-lampjes branden die vóór de inbouw niet brandden. Het snelheidsignaal nooit van het ABS-systeem aftakken.
